# ESP32 Series SoC

## Errata

Version 2.5  
Espressif Systems  
Copyright © 2022

This document details hardware errata and workarounds in the ESP32.

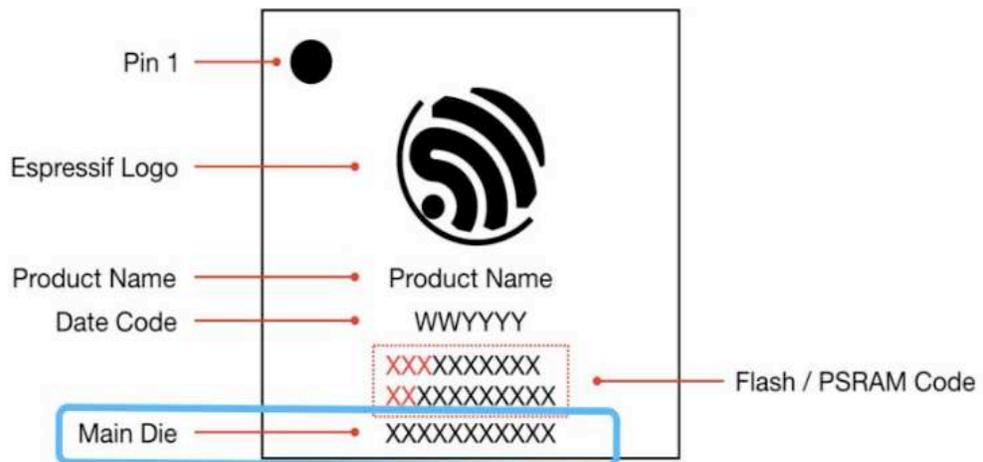
Figure 1-1: Chip Marking Diagram

- **Main Die** line in chip marking, see the figure below.

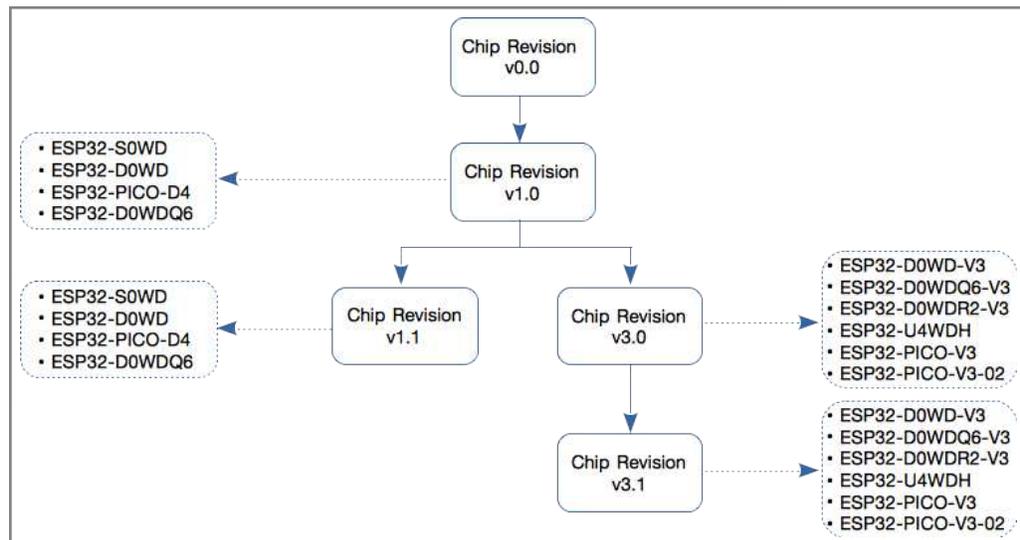
Figure 1-2: Chip Revisions and Chip Variants

The figure below shows the relation between chip revisions and chip variants.

- ESP32-S0WD, ESP32-D0WD, ESP32-PICO-D4, and ESP32-D0WDQ6 will be produced with chip revision v1.1 inside, see [PCN20220901](#).
- ESP32-D0WD-V3, ESP32-D0WDQ6-V3, ESP32-D0WDR2-V3, ESP32-U4WDH, ESP32-PICO-V3, and ESP32-PICO-V3-02 will be produced with chip revision v3.1 inside, see [PCN20220901](#).
